# MALMESBURY MARKET CROSS

2023 Condition Survey

- 1.1.1 This is the report of the condition survey and inspection of the Malmesbury Market Cross, undertaken on the 24<sup>th</sup> May 2023 by Izaak Hudson RIBA AABC.

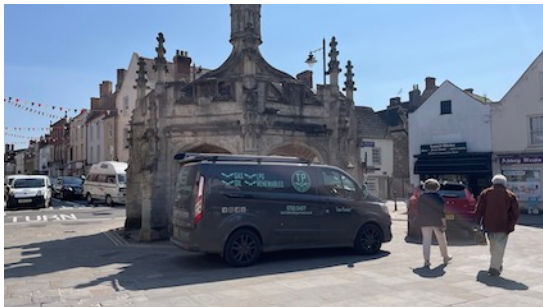
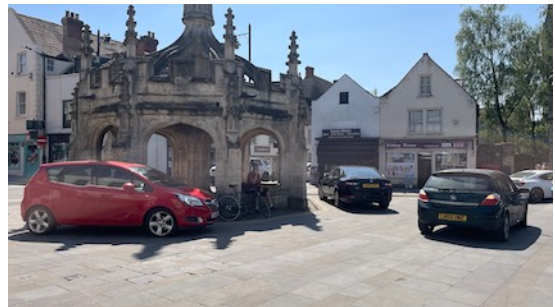
Photos 1.4.5a & 1.4.5b: The monument crowded by vehicles

1.4.6 The monument needs protection with wider pavements; a high kerb; bollards; traffic control. This would require a landscape project that will have to extend into the square. This is probably the most important recommendation of the condition survey.

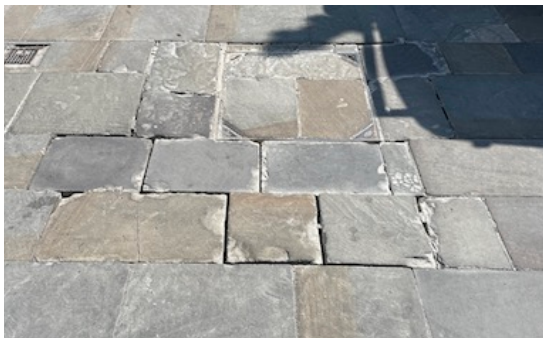
Photo 1.4.5c: Damaged paving from vehicles

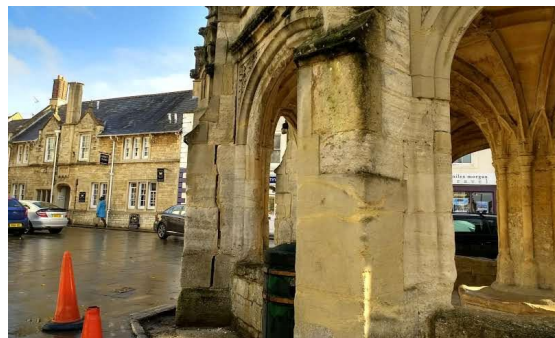
Photo 1.4.5d: Vehicle strike damage in 2018

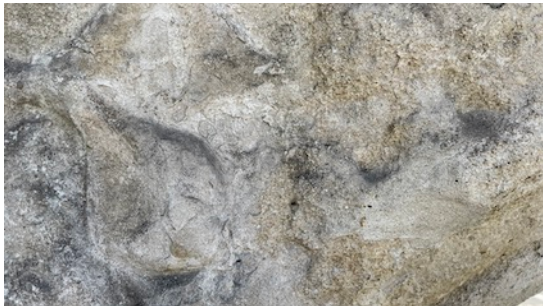
Photo 1.2a

- 1.2 Bay 1 (N) has a very weathered spandrel to the east (photos 1.2a and 1.2b), and a crisper, leaf-carved spandrel to the west. There is some scaling to the east spandrel and arch stone. The low-level ashlar is very worn and joints are washed out and would benefit from pointing (2). The buttress crocket finials are intact (they are 'engaged' stone so will be secure) – see photo 1.2c. There is some weathering of stone below the parapet, and to the base stone (photo 1.2d), but this doesn't warrant conservation work for now. Moss should be removed from the string course (1). The buttress finial to the south is secure.

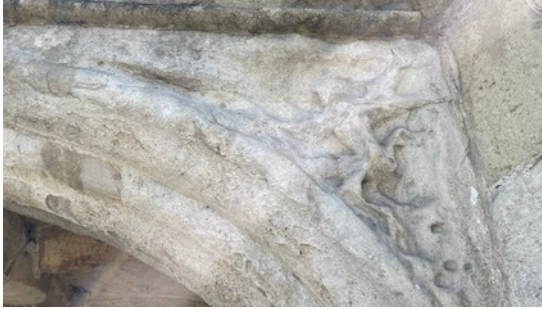
Photo 1.3a

- 1.3 Bay 2 (NE) has quite weathered spandrels (photo 1.3a) and the arch stonework is quite scaled (photo 1.3b). There is a small area of mechanical damage to the south and some blistering to the north (photos 1.3c and 1.3d), however, no conservation work is warranted for now. A finial crocket head to the south is loose. It is secured by a rod but needs to be re-pinned and pointed (1) – see photo 1.3e. The parapet stonework is weathered, but apart from moss removal (1), no conservation work is warranted.

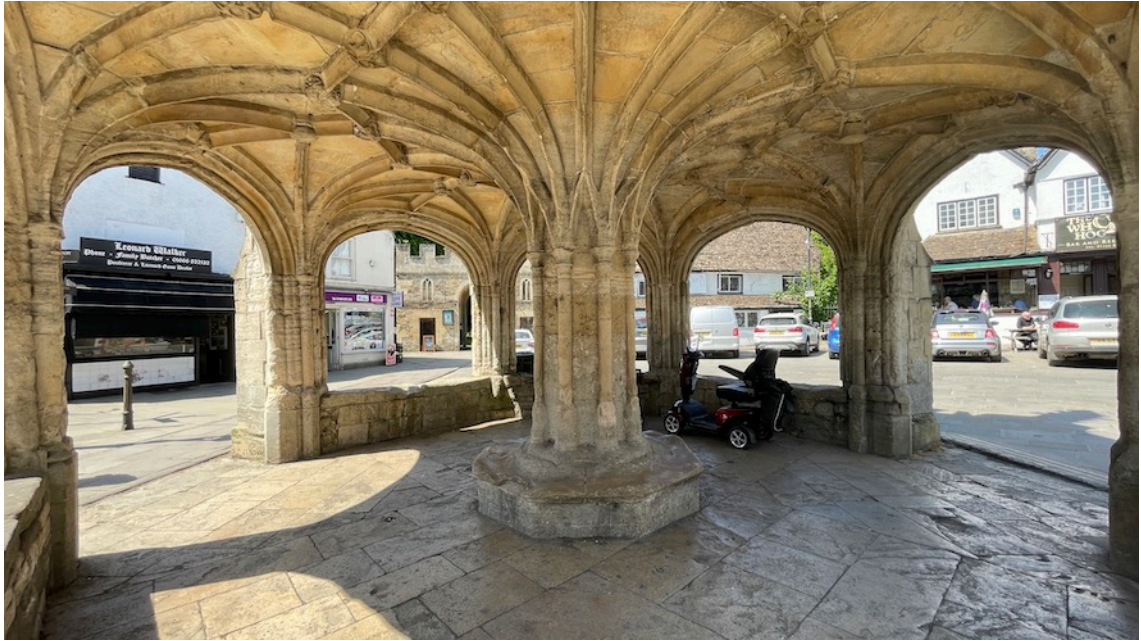
Photo 2.1

- 2.1 The interior is formed from a central, octagonal shaft and eight four-centred perimeter arches. Ribbed tierceron vaulting springs from the shaft and arch piers. Floor paving is limestone, almost certainly replaced in the twentieth century. The arch openings are infilled on six sides with low-level mixed coursed stone – some in regular courses and some in ashlar, of a variety of limestones and sandstones. The infill walling has been in place since at least 1683 (it is shown on the engraving of this date). The northeast (Bay 2) and southwest (Bay 6) arches are open for access.

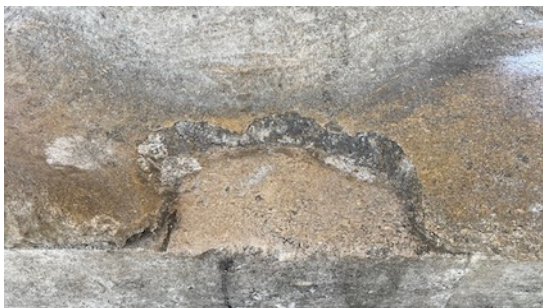
Photo 2.2a

- 2.2 The central shaft has a very worn bench seat. The shaft base above is very scaled with spalling stone. All carving detail has gone. Some conservation work would be ideal, but it might be vulnerable to damage at sitting level.

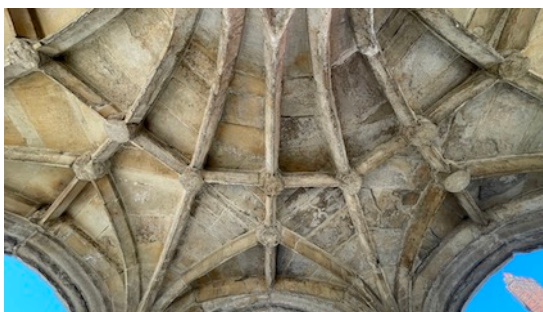
Photo 2.4a

- 2.4 Sections of vaulting have been previously replaced to Bays 3 (east); Bays 4/ 5 (south); Bays 6/ 7 (west – almost entirely replaced); and Bay 8, although some bosses were retained. The vaulting generally is in good condition. Some bosses retain crisp carving; some are weathered and the replacements to Bays 3/ 4 have been left entirely uncarved (a Brakspear motif). No stone repairs are warranted. There is some green algae staining to the east (Bay 3). It's not clear what has caused this as there is no evidence of water ingress to the roofspace above. Some pointing here is loose and would benefit from repointing (3).

| <b>3.00</b> | <b><u>Work which should be undertaken in the longer-term (but still important to achieve)</u></b> | <b>Under-taken by TC</b> | <b>Text Reference</b> | <b>Approx Cost (£)</b> |
|---|---|---|---|---|
| 3.01 | Repoint the internal vault pointing in localised places, including access. | N | 2.4 | 2,000 |

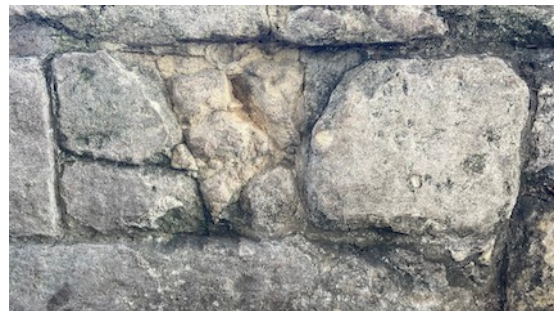
Photo 2.6b

- 2.5 The arch stonework is scaled in places, but is intact and could be left to slowly weather.
- 2.6 The outer shaft stonework to Bay 1 (N) is scaled in places. There are mortar repairs to the west jamb. All is fine for now. The low wall is of weathered coursed ashlar with infill stones to the west. Some are fractured and would benefit from mortar repairs (2) – see photo 2.6b.

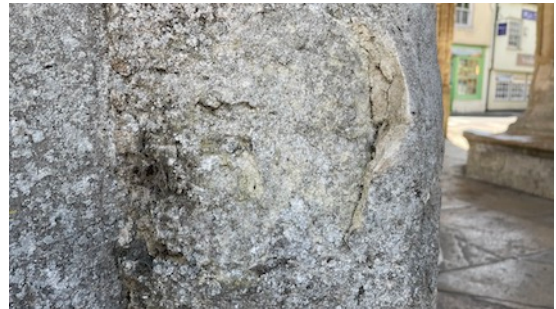
Photo 2.7b

- 2.7 The open Bay 2 (NE) stone surrounds are weathered to the north. There is a fractured stone to the south at low level which needs a mortar repair to protect it from being knocked off and losing the face (2) – see photo 2.7b.

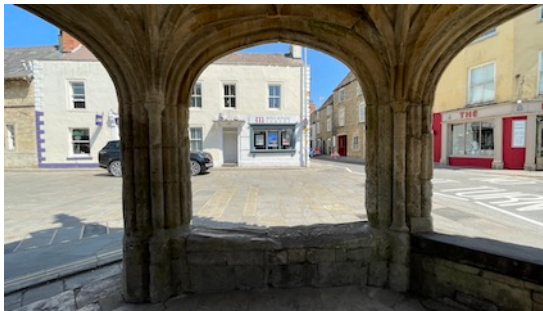
Photo 2.8a

- 2.8 The outer stonework to Bay 3 (E) is generally in good condition. There is a piecing-in repair to the north which is cracked and eroded on both sides of the perp joint (photo 2.8b), but is fine to leave for now. The limestone wall copings are very worn but intact.

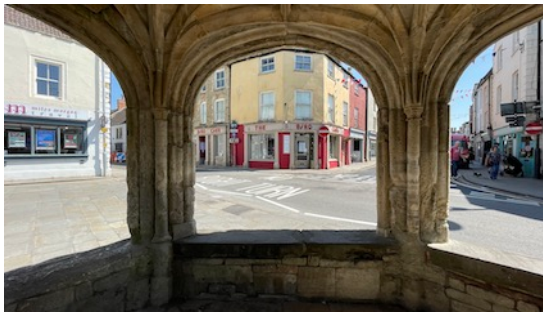
Photo 2.9a

- 2.9 Outer stonework to Bay 4 (SE) is scaling in places but is generally sound. The wall copings are sandstone which might be accelerating run-off decay below. An area to the south is undercut but is fine to leave for now.

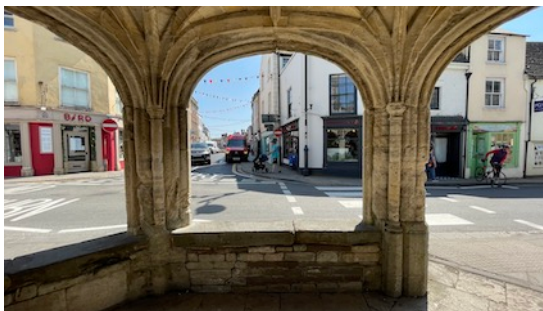
Photo 2.10a

- 2.10 The east jamb of Bay 5 (S) is very eroded at the base. Stone replacement will be needed in time (3) for now de-frassing and shelter coating may prolong the life of the stone (2). The wall is of squat, coursed squared-rubble with sandstone copings and is markedly different from the outer low wall stonework. Joints are open but the rounded rubblestones won't take re-pointing well.

| <b>3.00</b> | <b><u>Work which should be undertaken in the longer-term (but still important to achieve)</u></b> | <b>Under-taken by TC</b> | <b>Text Reference</b> | <b>Approx Cost (£)</b> |
|---|---|---|---|---|
| 3.02 | Replace the very eroded stone to the east outer jamb of Bay 5 (S). | N | 2.10 | 750 |

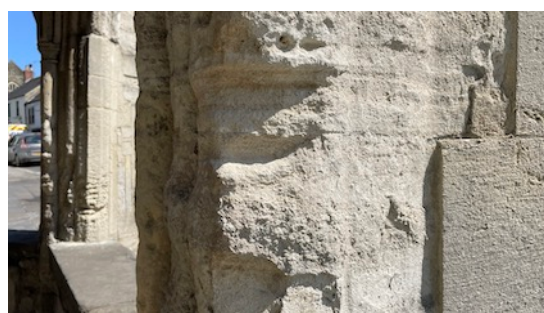
Photo 2.11b

- 2.11 The outer stonework to Bay 6 (SW) is scaled. The south jamb is friable and would benefit from de-frassing and shelter coating to prolong its life (2).

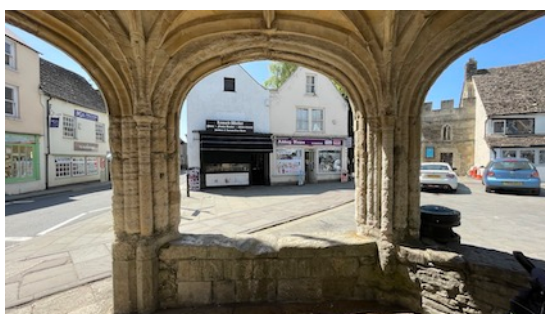
Photo 2.12a

- 2.12 The outer stonework to Bay 7 (W) is free of any major issues. A jamb stone to the north is cracked but repair isn't warranted for now – see photo 2.12b.

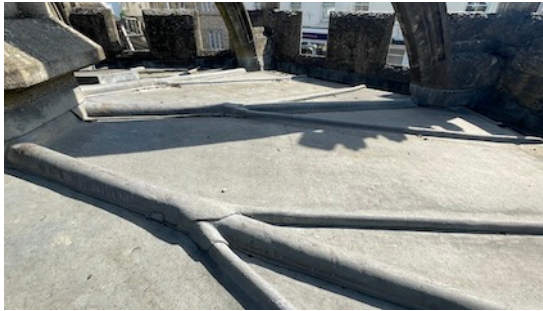
Photo 3.2a

- 3.2 Lead bays are a maximum of 2.5m long by 0.8m girth, which is adequate for code 7 lead or thicker. Boards are showing through in places, and there are four lead patches. The lead welds to three of these have hairline cracks and should be replaced with larger patches (1) – see photo 3.2b. The upper gutter bays (ie. bays without catch pits) are formed from single pieces of lead welded to a small apron at the catch pit. They are therefore restrained at the point the lead passes through the buttresses. This lead weld will be prone to splitting (a tiny split is forming to Bay 1 (N) – see photo 3.2d). These points should regularly be inspected and lead patch repaired when required (1).

| <b>U</b> | <b><u>Work which should be undertaken urgently</u></b> | <b>Under-taken by TC</b> | <b>Text Reference</b> | <b>Approx Cost (£)</b> |
|---|---|---|---|---|
| 1.04 | Commission a programme of minor lead repairs – replace lead patches to three lead patches on the roof. Regularly inspect the restrained upper lead gutter bays and patch weld any forming cracks. Replace the gutter upstand lead patch to Bay 7 (W). Repair the crumpled end to the drainage chute to Bay 5 (S), including access. | N | 3.2; 3.5; 3.6 | 1,500 |

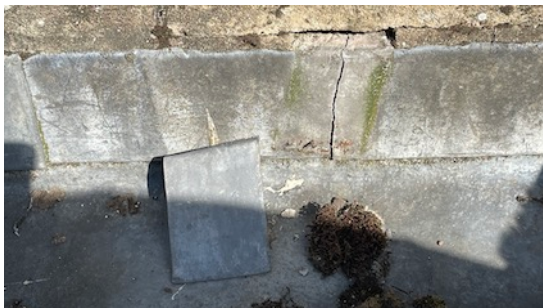
Photo 3.5a

- 3.5 Parapet flashings have small flashing patches over splits (the flashing are over-long). The Bay 7 (W) patch has come out and needs to be wedged and re-mortared (1) – see photo 3.5a. It is suspected that these patches are not wedged and all may need attention in forthcoming years as thermal movement loosens them (3). The flashing to Bay 6 (SW) has a crack which needs a patch in the longer term (3) – see photo 3.5c.

| <b>3.00</b> | <b><u>Work which should be undertaken in the longer-term (but still important to achieve)</u></b> | <b>Under-taken by TC</b> | <b>Text Reference</b> | <b>Approx Cost (£)</b> |
|---|---|---|---|---|
| 3.03 | Replace the lead patches to the gutter flashings, or renew the flashings in shorter lengths. | N | 3.5 | 2,500 |

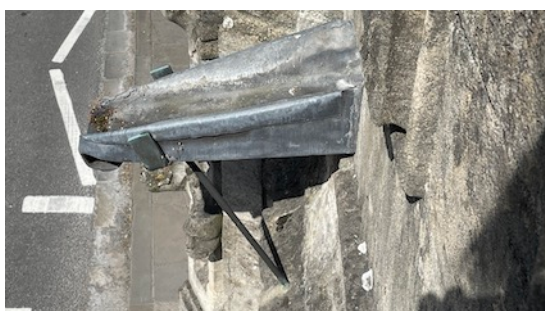
Photo 3.6a

- 3.6 The four drainage chutes are held on bronze Y-brackets. The end of chute to Bay 5 (S) is crumpled due to damage and needs to be repaired (1) – see photo 3.6a.

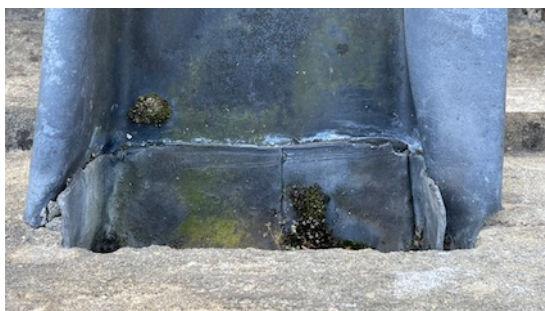
Photo 3.7

- 3.7 The chute to Bay 6 (E) has a lap joint which has a mastic bed (which has failed) – see photo 3.7. Ideally the lead chute should be a single piece, as other chutes, but the joint is beyond the outer stone moulding so any leaks shouldn't be too problematic as they will drain externally.

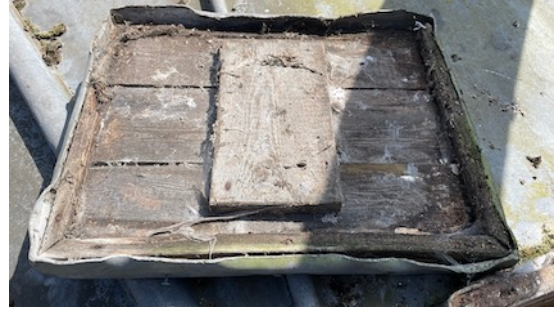
Photo 3.9b

- 3.9 There is a lead lined timber hatch to Bay 2 (NE) which allows access to the vaults beneath. The timber hatch is rotten and needs to be re-formed (2).

| <b>2.00</b> | <b><u>Work which should be undertaken within the next 4-5 years</u></b> | <b>Under-taken by TC</b> | <b>Text Reference</b> | <b>Approx Cost (£)</b> |
|---|---|---|---|---|
| 2.03 | Replace the rotten roof hatch. | N | 3.9 | 1,250 |

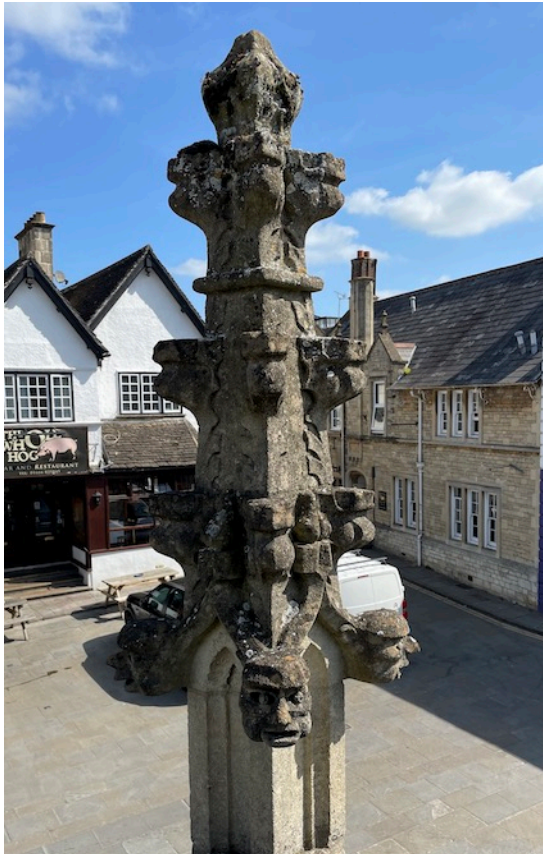
Photo 3.11a

- 3.11 The crocketed finials all appear to be in good condition visually. The two flanking finials to Bay 1 (N) (photos 3.11a and 3.11h) both wobble about the bed joint. They will undoubtedly have metal internal rods, so should be secure, but they do need re-setting and additional bed joint dowels to strengthen them (1).

| <b>U</b> | <b><u>Work which should be undertaken urgently</u></b> | <b>Under-taken by TC</b> | <b>Text Reference</b> | <b>Approx Cost (£)</b> |
|---|---|---|---|---|
| 1.02 | Re-pin and repoint the loose finial projecting small crocket figurative heads to Bay 2 (NE); Bay 5 (S); and Bay 7 (W); and re-secure the entire length of the two flanking finials to Bay 1 (N). | N | 1.3; 1.6; 1.8; 3.11 | 1,800 |

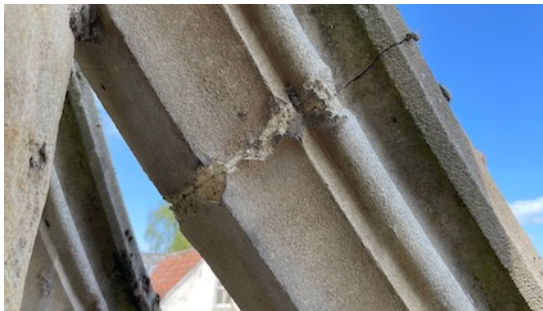
Photo 3.13a

3.13 The eight flying buttresses are in good condition. There are some small areas of stone blistering, loss of pointing and frost damage to a roll-mould, but nothing that would warrant repair for now.

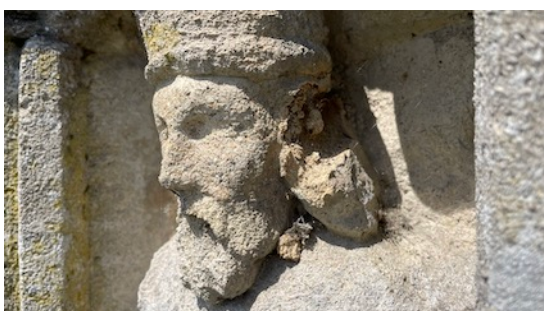
Photo 3.15a

- 3.15 The fine carving is vulnerable to weathering. There are a lot of previous mortar repairs, some of high quality, and some are now detaching. There is blistering to the left ear of King Athelstan , and to the cusped mould over Bay 5 (S). Protective lead weather hoods may arrest deterioration, and some conservation treatment would be ideal to prolong the life of the statuary (2) – this may be more cost-effective by rope access.

| <b>2.00</b> | <b><u>Work which should be undertaken within the next 4-5 years</u></b> | <b>Under-taken by TC</b> | <b>Text Reference</b> | <b>Approx Cost (£)</b> |
|---|---|---|---|---|
| 2.04 | Commission a programme of rope access conservation repairs to the vulnerable lantern statuary. | N | 3.15 | 5,000 |

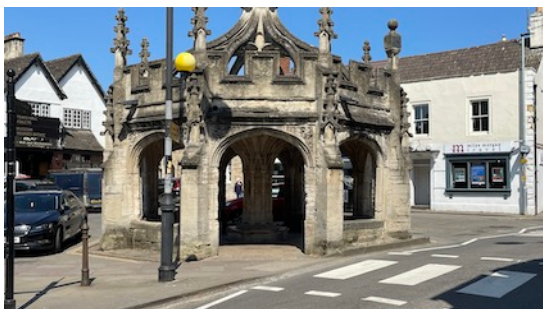
Photo 4.3a

- 4.2 Re-paving the margin stonework with dished channels and better falls from the south in particular would be desirable (**4**).
- 4.3 A high sandstone kerb to the south road provides limited protection from vehicles. Lorries in particular struggle to make the turn from High Street to Gloucester Street and there is a high risk of vehicle strike here, but there might not be much scope for improvement to the junction. CCTV coverage would be very useful to cover this junction so that vehicle strike damage can be pursued via vehicle insurance – HGVs are frequently routed through the town when drivers use inappropriate sat navs (**4**).

| <b>4.00</b> | <b><u>Work which is desirable but non-essential</u></b> | <b>Under-taken by TC</b> | <b>Text Reference</b> | <b>Approx Cost (£)</b> |
|---|---|---|---|---|
| 4.02 | Install CCTV cameras and enforce traffic restrictions at the junction between the High Street and Gloucester Street to reduce the risk of vehicle strikes against the monument at this vulnerable point; and to discourage unauthorised access to the roof of the Market Cross. | N | 4.3; 4.6 | Unknown |

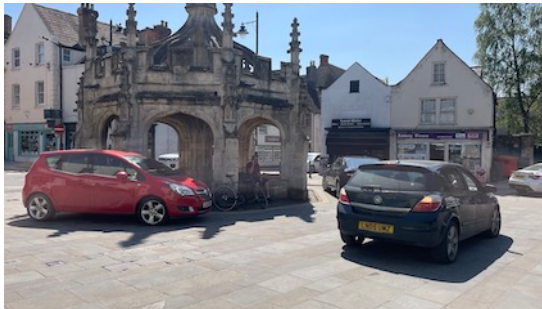
Photo 4.4a

- 4.4 The parking area to the north creates high risks with reversing vehicles. Although there are double yellow lines around the Market Cross, there is a near constant stream of vehicles parked here, some legitimately with blue badges but mostly just for short stop-offs to use the shops. This mars the setting of the Market Cross. The constant vehicle movements mean a high risk of vehicle strikes; most probably causing more damage to the vehicles than the masonry, but a waste lorry caused substantial damage recently. The stone paving in the square is deteriorating in places (see photo 4.4d). Re-landscaping of the area around the Market Cross would be a substantial benefit – wider pavements and a higher kerb with cast iron bollards would substantially protect the building and improve the setting (4). Developing a landscaping project here would probably be the best value project to protect the Market Cross fabric (1).

| <b>4.00</b> | <b><u>Work which is desirable but non-essential</u></b> | <b>Under-taken by TC</b> | <b>Text Reference</b> | <b>Approx Cost (£)</b> |
|---|---|---|---|---|
| 4.03 | Deliver a re-landscaping project to the north of the monument to protect it from vehicle strikes and improve the setting; wider pavements; higher kerbs against the Market Cross; bollards; replacement stone paving and traffic exclusion measures. | N | 4.4 | 50,000 |
