# MALMESBURY MARKET CROSS

2023 Condition Survey

- 1.1.1 This is the report of the condition survey and inspection of the Malmesbury Market Cross, undertaken on the 24<sup>th</sup> May 2023 by Izaak Hudson RIBA AABC.

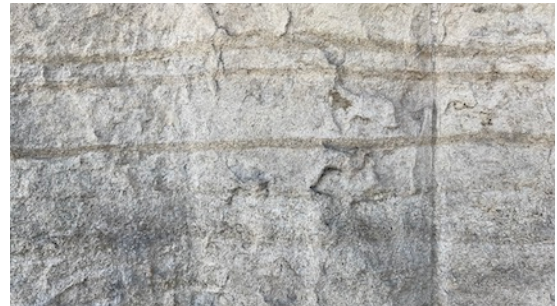
Photo 1.2b

- 1.2 Bay 1 (N) has a very weathered spandrel to the east (photos 1.2a and 1.2b), and a crisper, leaf-carved spandrel to the west. There is some scaling to the east spandrel and arch stone. The low-level ashlar is very worn and joints are washed out and would benefit from pointing (2). The buttress crocket finials are intact (they are 'engaged' stone so will be secure) – see photo 1.2c. There is some weathering of stone below the parapet, and to the base stone (photo 1.2d), but this doesn't warrant conservation work for now. Moss should be removed from the string course (1). The buttress finial to the south is secure.

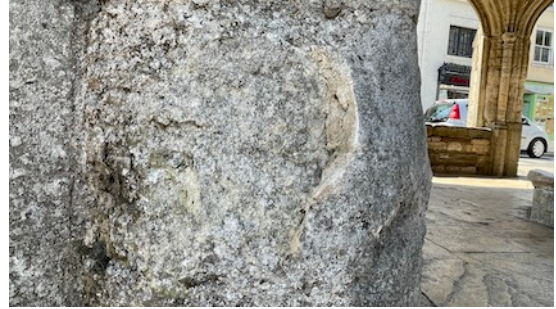
Photo 1.3b

- 1.3 Bay 2 (NE) has quite weathered spandrels (photo 1.3a) and the arch stonework is quite scaled (photo 1.3b). There is a small area of mechanical damage to the south and some blistering to the north (photos 1.3c and 1.3d), however, no conservation work is warranted for now. A finial crocket head to the south is loose. It is secured by a rod but needs to be re-pinned and pointed (1) – see photo 1.3e. The parapet stonework is weathered, but apart from moss removal (1), no conservation work is warranted.

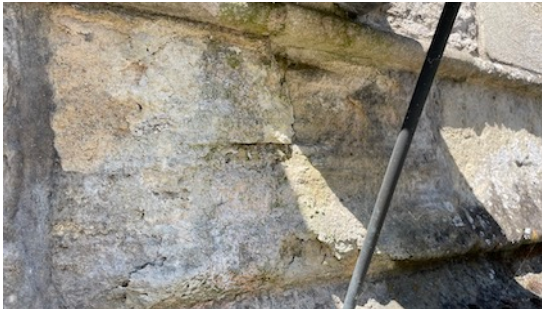
Photo 1.4c

- 1.4 Bay 3 (E) has very weathered spandrels and arch stonework. There's been some stone replacement to the north arch. An area of stone beneath the gutter spout is very friable (see photo 1.4c) and needs extensive full-face mortar repairs, or replacement with stone-tile repairs or stone replacement (2). Moss needs to be removed (1). There is a crack to the mortar behind a previous, poorly-pieced-in stone repair to the north buttress arris (photo 1.4d). Ideally a replacement stone-piecing-in should be fitted, coursed to match the joints (2).

| <b>2.00</b> | <b><u>Work which should be undertaken within the next 4-5 years</u></b> | <b>Under-taken by TC</b> | <b>Text Reference</b> | <b>Approx Cost (£)</b> |
|---|---|---|---|---|
| 2.01 | Commission a small programme of stone repairs – Mortar repair or fit stone replacements to the friable stone beneath the gutter spout to Bay 3 (E); repair the small crack to the Bay 3 north buttress arris; repair the small crack to the Bay 5 (S) buttress arris; rake-back and repoint the small crack to the Bay 7 (W) jamb stone; mortar repair fractured external plinth stonework on Bay 1 (N); mortar repair the spalling external plinth stone to Bay 2 (NE); de-frass and shelter coat the very eroded stone to the east outer jamb of Bay 5 (S); and the south jamb of Bay 6 (SW). | N | 1.3; 1.6; 1.8; 2.6; 2.7; 2.10; 2.11 | 2,500 |

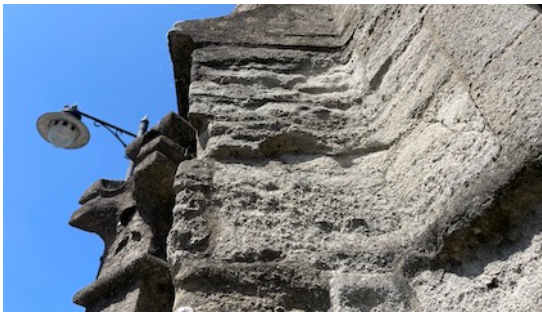
Photo 1.6c

- 1.6 Bay 5 (S) spandrel carvings are completely missing now due to stone weathering. The arch visibly sags but this is most likely to be historic movement. There has been quite a bit of stone replacement to the west parapet. Older stones are very weathered, particularly to the west buttress head (photo 1.6c). There is a crack to the west buttress arris (photo 1.6d) which needs a stone piecing-in repair **(2)**. One of the crocket heads to the west is loose and needs to be pinned and pointed in **(1)** – see photo 1.6e. Low-level stonework is weathered (photo 1.6f) but pointing is still intact.

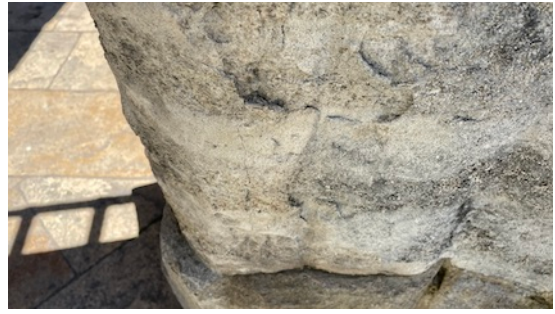
Photo 1.7b

- 1.7 Bay 6 (SW) has two intact carved spandrels (the entire arch head is replacement stone). There is some scaling to the east arch joint (photo 1.7b). The band of stone above the projecting cornice is quite friable and previous mortar repairs have fallen off. For now, it would probably be best to leave it to weather before intervention is warranted.

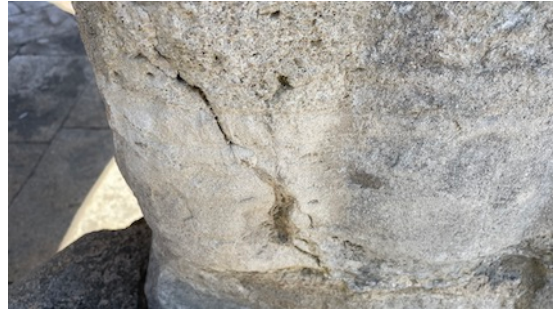
Photo 1.8b

- 1.8 Bay 7 (W) spandrel and arch stonework is all replacement stone and is weathering well. A lower jamb stone has a crack (photo 1.8b) which could be raked-back and pointed (2) and there is some scaling to the south buttress (photo 1.8c). The finial head to the south (photo 1.8d) has a crack at the neck and wobbles – it should be pinned and pointed in (1).

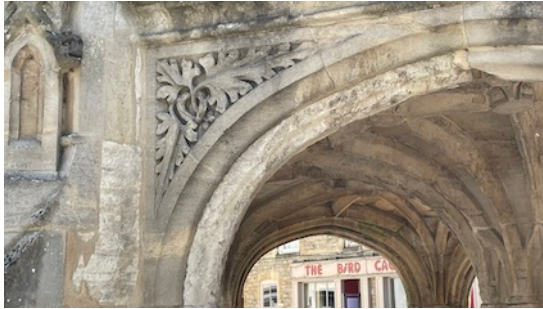
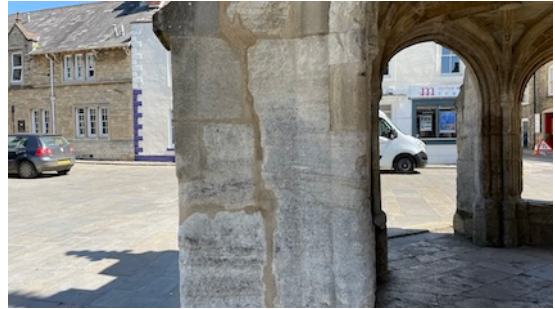
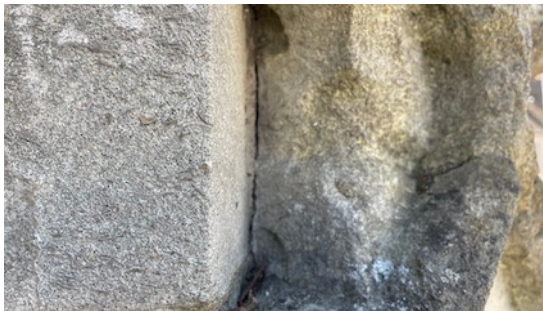
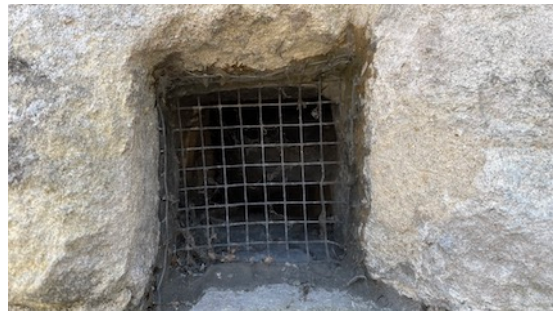
- 1.9 Bay 8 (NW) has crisply-carved spandrel replacements. The lower-level jambs have some scaling and there is erosion to the seat stone at the base, but generally, this bay is in good order. The buttress to the east (to Bay 1) has had recent deep pointing repairs by the contractor AC Nurden Ltd. following a waste lorry strike (photo 1.9b). Mortar is all intact. The west buttress finial has an open perp joint behind – it is a replacement stone so might just have been poorly bedded. The vent opening for the roof space has been infilled with mesh fixed with resin – it is secure for now but this isn't the best fixing method -see photo 1.9d. These openings should be regularly inspected as pigeons must not be allowed back into the roof space (1). The rusting litter bin here should be replaced or relocated as it mars the setting of the Grade I listed building (2).

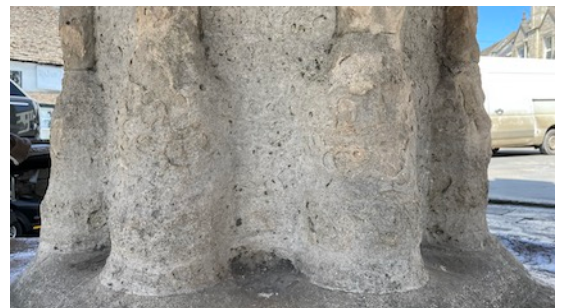
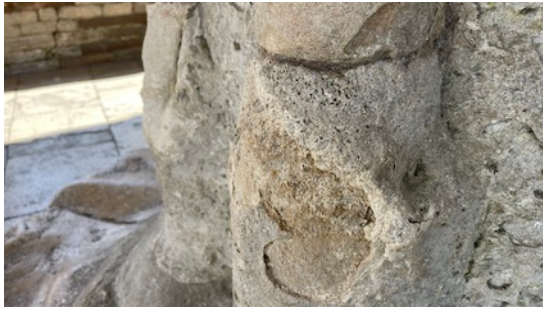
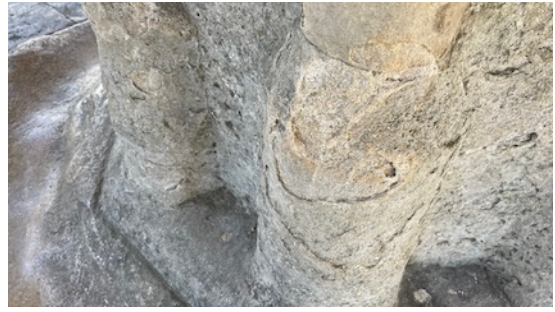
- 2.2 The central shaft has a very worn bench seat. The shaft base above is very scaled with spalling stone. All carving detail has gone. Some conservation work would be ideal, but it might be vulnerable to damage at sitting level.

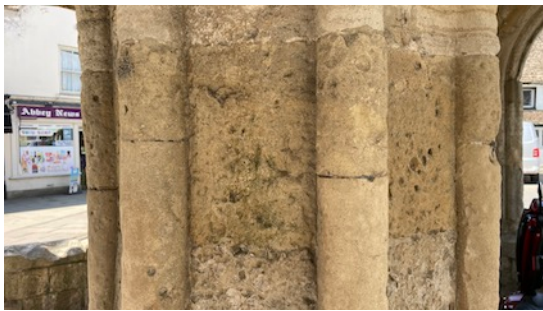
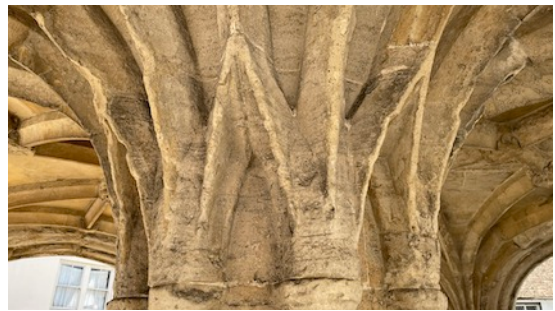
- 2.3 The main pier has had replacement shafts on all sides. These are weathered but still intact. The capitals have interesting hood arches from which spring the 16 ribs. These have had mortar repairs in the past which are now eroded. They are probably fine to leave to weather-back.

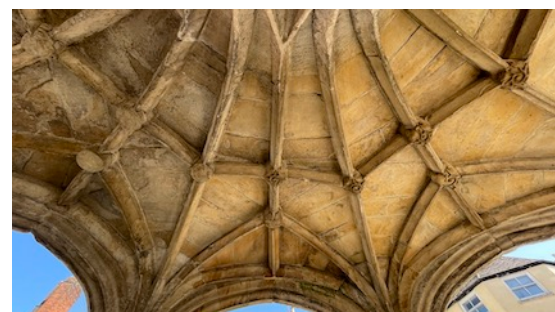
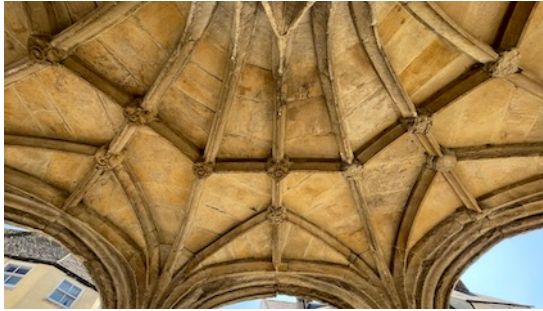
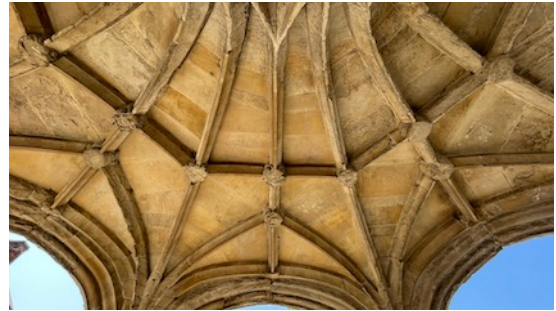
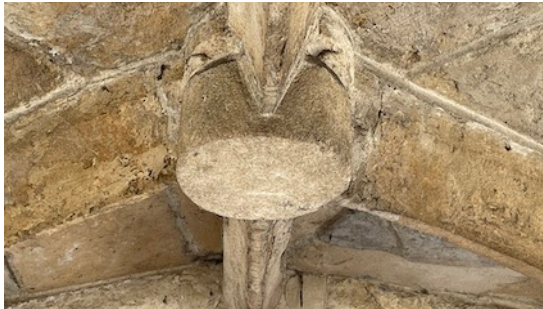
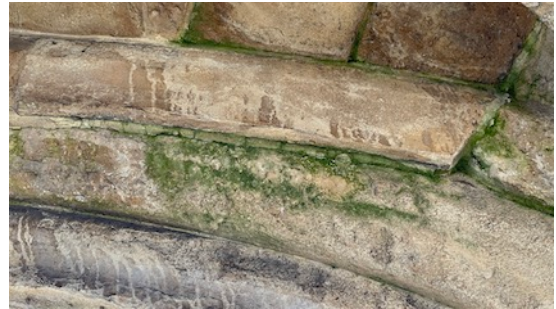
- 2.4 Sections of vaulting have been previously replaced to Bays 3 (east); Bays 4/ 5 (south); Bays 6/ 7 (west – almost entirely replaced); and Bay 8, although some bosses were retained. The vaulting generally is in good condition. Some bosses retain crisp carving; some are weathered and the replacements to Bays 3/ 4 have been left entirely uncarved (a Brakspear motif). No stone repairs are warranted. There is some green algae staining to the east (Bay 3). It's not clear what has caused this as there is no evidence of water ingress to the roofspace above. Some pointing here is loose and would benefit from repointing (3).

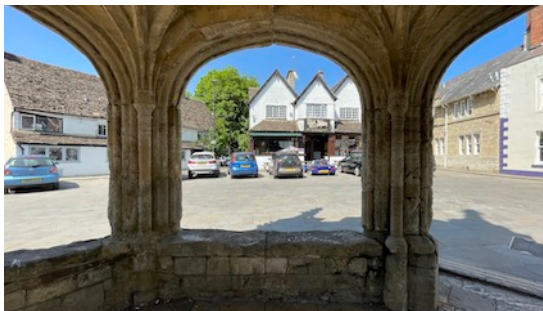
Photo 2.6a

- 2.5 The arch stonework is scaled in places, but is intact and could be left to slowly weather.
- 2.6 The outer shaft stonework to Bay 1 (N) is scaled in places. There are mortar repairs to the west jamb. All is fine for now. The low wall is of weathered coursed ashlar with infill stones to the west. Some are fractured and would benefit from mortar repairs (2) – see photo 2.6b.

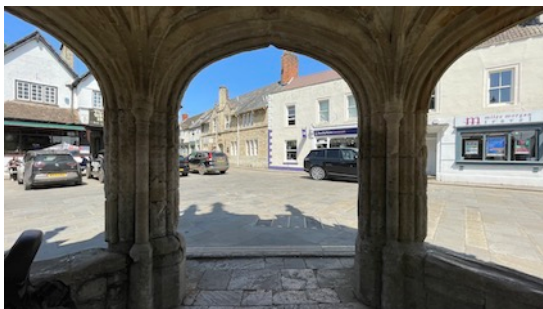
Photo 2.7a

- 2.7 The open Bay 2 (NE) stone surrounds are weathered to the north. There is a fractured stone to the south at low level which needs a mortar repair to protect it from being knocked off and losing the face (2) – see photo 2.7b.

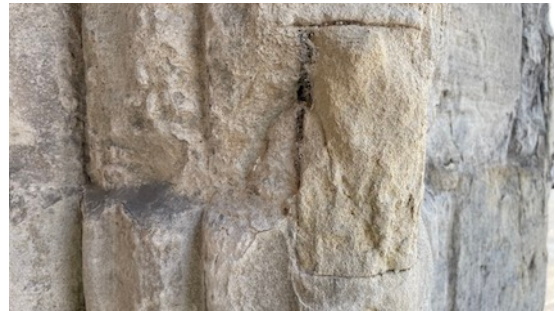
Photo 2.8b

- 2.8 The outer stonework to Bay 3 (E) is generally in good condition. There is a piecing-in repair to the north which is cracked and eroded on both sides of the perp joint (photo 2.8b), but is fine to leave for now. The limestone wall copings are very worn but intact.

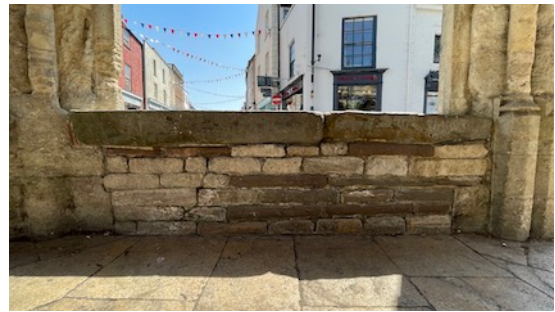
Photo 2.9b

- 2.9 Outer stonework to Bay 4 (SE) is scaling in places but is generally sound. The wall copings are sandstone which might be accelerating run-off decay below. An area to the south is undercut but is fine to leave for now.

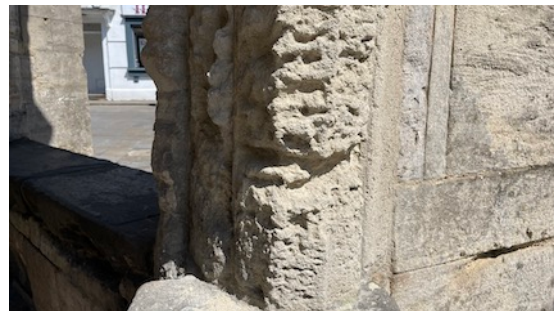
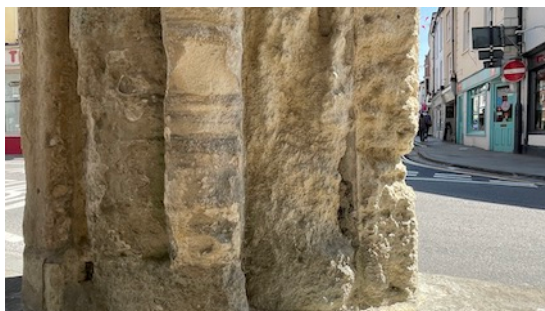
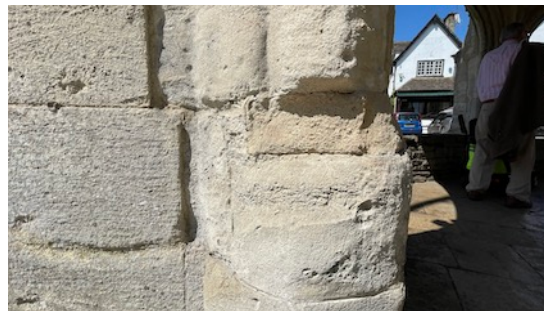
- 2.10 The east jamb of Bay 5 (S) is very eroded at the base. Stone replacement will be needed in time (3) for now de-frassing and shelter coating may prolong the life of the stone (2). The wall is of squat, coursed squared-rubble with sandstone copings and is markedly different from the outer low wall stonework. Joints are open but the rounded rubblestones won't take re-pointing well.

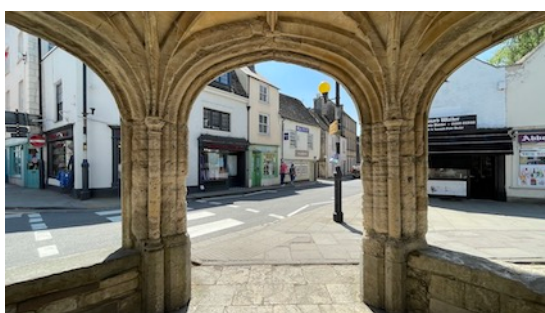
Photo 2.11a

- 2.11 The outer stonework to Bay 6 (SW) is scaled. The south jamb is friable and would benefit from de-frassing and shelter coating to prolong its life (2).

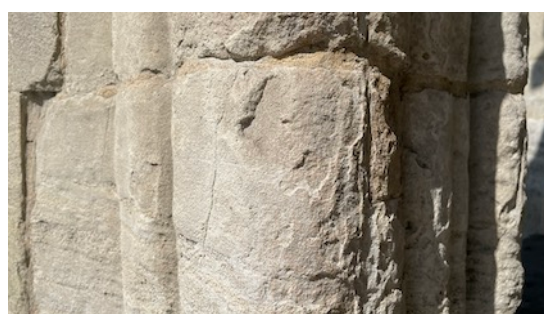
Photo 2.12b

- 2.12 The outer stonework to Bay 7 (W) is free of any major issues. A jamb stone to the north is cracked but repair isn't warranted for now – see photo 2.12b.

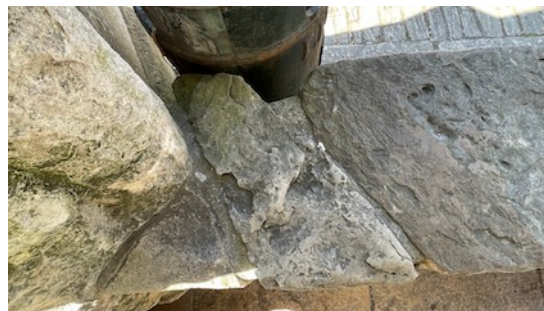
Photo 2.13b

- 2.13 The outer stonework to Bay 8 (NW) is scaled but is generally fine. The low wall is a mixture of coursed and jumper stone in limestone and sandstone. The coping is weathered sandstone – the western end is oddly jointed (see photo 2.13b).

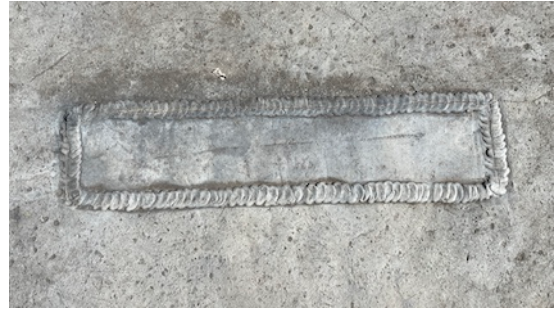
Photo 3.2b

- 3.2 Lead bays are a maximum of 2.5m long by 0.8m girth, which is adequate for code 7 lead or thicker. Boards are showing through in places, and there are four lead patches. The lead welds to three of these have hairline cracks and should be replaced with larger patches (1) – see photo 3.2b. The upper gutter bays (ie. bays without catch pits) are formed from single pieces of lead welded to a small apron at the catch pit. They are therefore restrained at the point the lead passes through the buttresses. This lead weld will be prone to splitting (a tiny split is forming to Bay 1 (N) – see photo 3.2d). These points should regularly be inspected and lead patch repaired when required (1).

| <b>3.00</b> | <b><u>Work which should be undertaken in the longer-term (but still important to achieve)</u></b> | <b>Under-taken by TC</b> | <b>Text Reference</b> | <b>Approx Cost (£)</b> |
|---|---|---|---|---|
| 3.03 | Replace the lead patches to the gutter flashings, or renew the flashings in shorter lengths. | N | 3.5 | 2,500 |

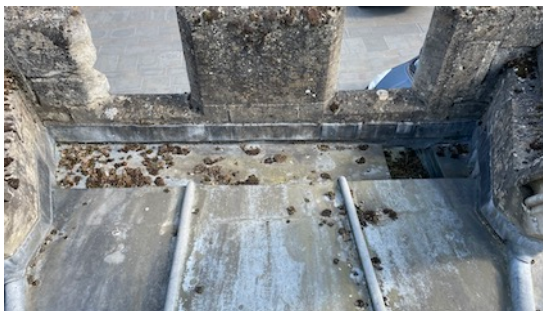
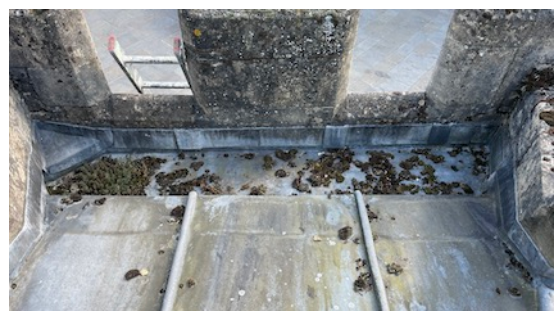
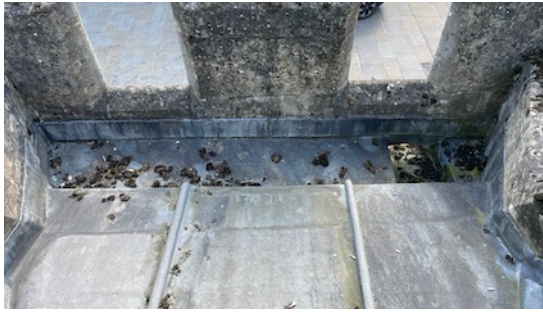
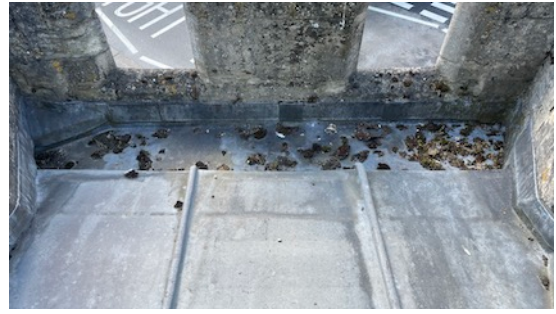
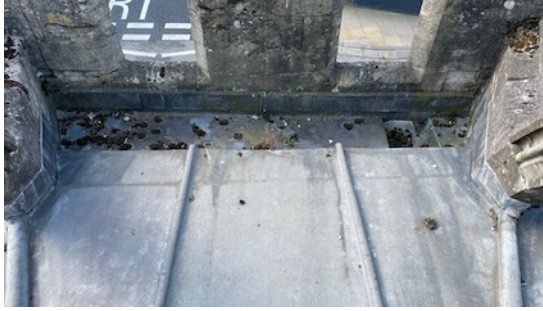
- 3.3 The flat leads on rolls are in fair condition. There is little moss which should be removed (1).
- 3.4 There is a minimum 120mm fall into the 350mm wide parapet gutters. Flashings are all secure and the lead is well-detailed.

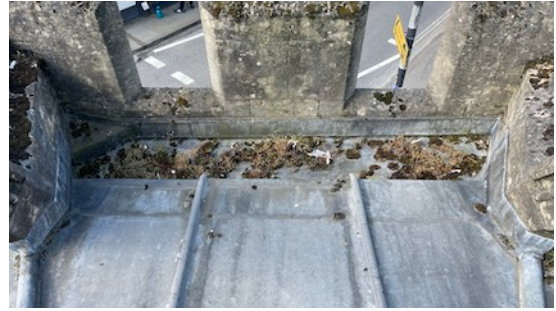
Photo 3.4f (Bay 6 SW)

- 3.5 Parapet flashings have small flashing patches over splits (the flashing are over-long). The Bay 7 (W) patch has come out and needs to be wedged and re-mortared (1) – see photo 3.5a. It is suspected that these patches are not wedged and all may need attention in forthcoming years as thermal movement loosens them (3). The flashing to Bay 6 (SW) has a crack which needs a patch in the longer term (3) – see photo 3.5c.

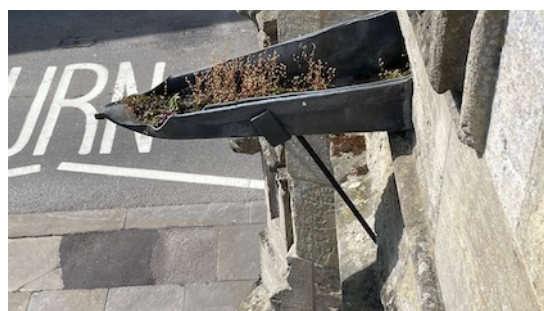
Photo 3.6a

- 3.6 The four drainage chutes are held on bronze Y-brackets. The end of chute to Bay 5 (S) is crumpled due to damage and needs to be repaired (1) – see photo 3.6a.

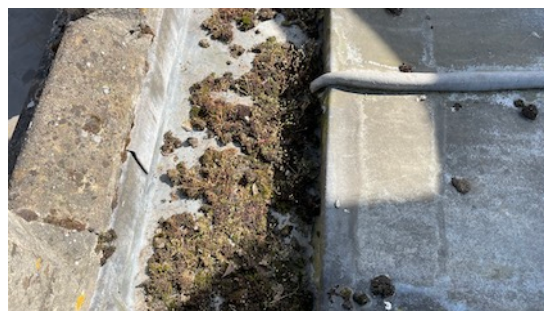
Photo 3.7

- 3.7 The chute to Bay 6 (E) has a lap joint which has a mastic bed (which has failed) – see photo 3.7. Ideally the lead chute should be a single piece, as other chutes, but the joint is beyond the outer stone moulding so any leaks shouldn't be too problematic as they will drain externally.

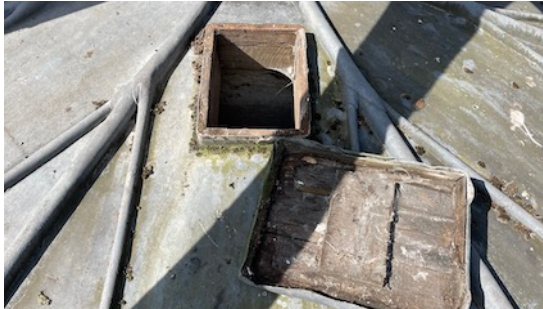
Photo 3.8

- 3.8 There is a high level of moss in gutters (as well as stonework) and this should all be removed by hand with a spatula and water (1) – see photo 3.8.

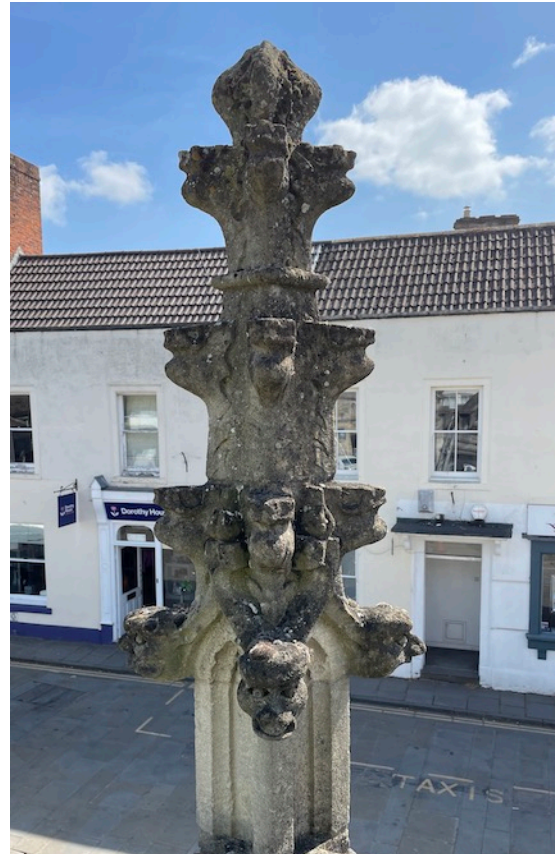
Photo 3.11a

- 3.11 The crocketed finials all appear to be in good condition visually. The two flanking finials to Bay 1 (N) (photos 3.11a and 3.11h) both wobble about the bed joint. They will undoubtedly have metal internal rods, so should be secure, but they do need re-setting and additional bed joint dowels to strengthen them (1).

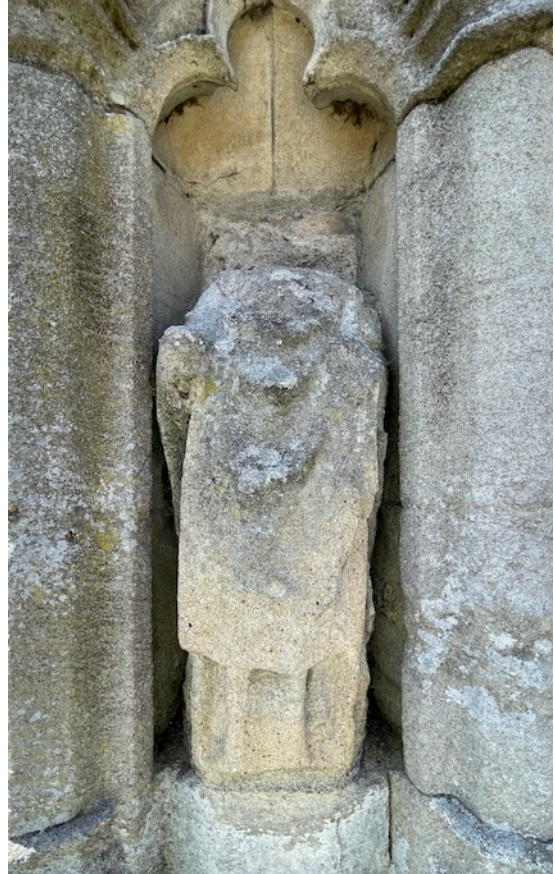
Photo 3.14b (Bay 2 NE – St Aldhelm)

- 3.14 The lantern statuary almost certainly dates from the twentieth century (they were all reported to be traces only in 1909). They are difficult to access for inspection, but some are clearly not aging well. The stone is eroded and some statues are barely discernible. The statue of St Aldhelm to Bay 2 (NE) is missing a head and the statue in Bay 5 (S) is completely eroded (and might be pre-1909). Pigeons perch on the statuary heads and guano will accelerate stone erosion, but little can be done about this.

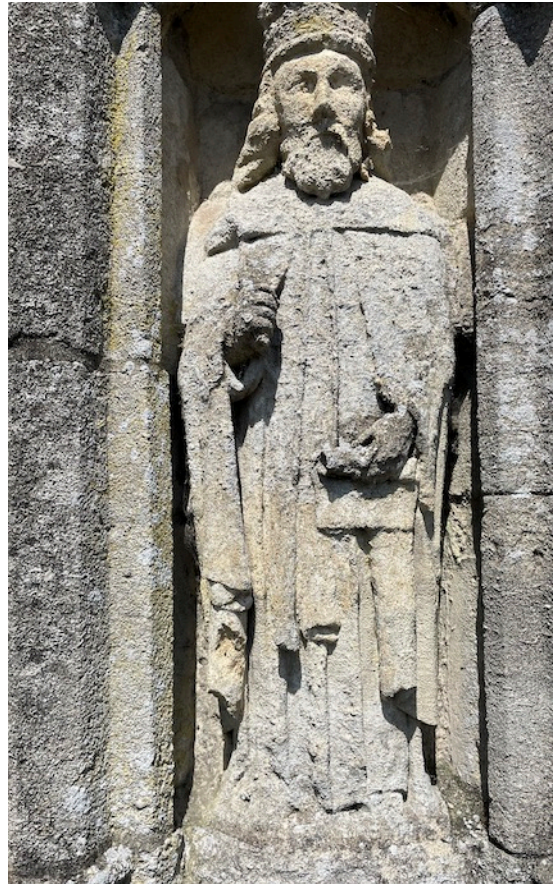
Photo 3.14d (Bay 4 SE – King Athelstan)

- 3.15 The fine carving is vulnerable to weathering. There are a lot of previous mortar repairs, some of high quality, and some are now detaching. There is blistering to the left ear of King Athelstan , and to the cusped mould over Bay 5 (S). Protective lead weather hoods may arrest deterioration, and some conservation treatment would be ideal to prolong the life of the statuary (2) – this may be more cost-effective by rope access.

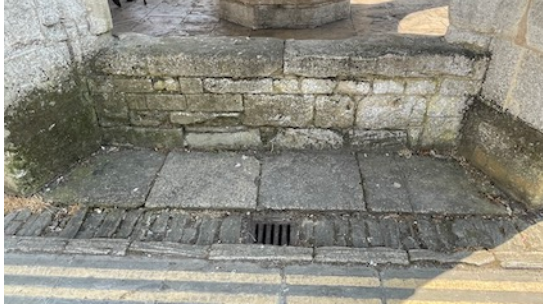
Photo 4.1a

- 4.1 The waterspouts drain to a stone set margin which drains to gullies to the north (photo 4.1 a), east (photo 4.1b) and west (photo 4.1c). The south spout water thus has a long route to drain to the side gullies across a threshold (photo 4.1d) – water probably just sinks into the ground. The east and west gullies need cleaning out as a matter of urgency (**U**).

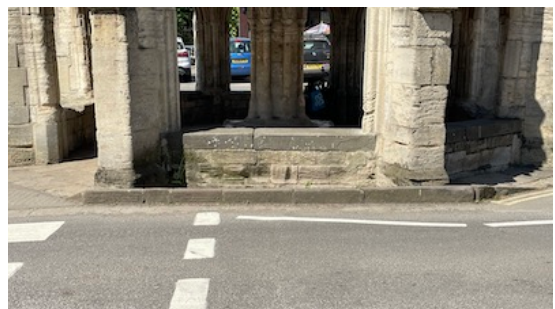
Photo 4.3b

- 4.2 Re-paving the margin stonework with dished channels and better falls from the south in particular would be desirable (**4**).
- 4.3 A high sandstone kerb to the south road provides limited protection from vehicles. Lorries in particular struggle to make the turn from High Street to Gloucester Street and there is a high risk of vehicle strike here, but there might not be much scope for improvement to the junction. CCTV coverage would be very useful to cover this junction so that vehicle strike damage can be pursued via vehicle insurance – HGVs are frequently routed through the town when drivers use inappropriate sat navs (**4**).

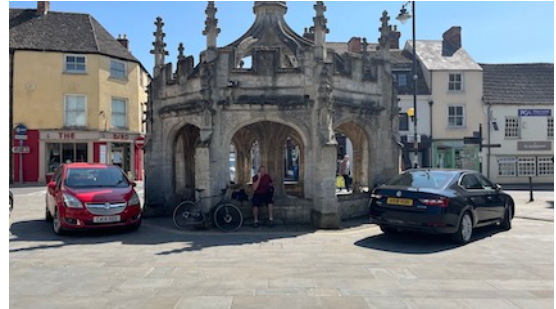
Photo 4.4b

- 4.4 The parking area to the north creates high risks with reversing vehicles. Although there are double yellow lines around the Market Cross, there is a near constant stream of vehicles parked here, some legitimately with blue badges but mostly just for short stop-offs to use the shops. This mars the setting of the Market Cross. The constant vehicle movements mean a high risk of vehicle strikes; most probably causing more damage to the vehicles than the masonry, but a waste lorry caused substantial damage recently. The stone paving in the square is deteriorating in places (see photo 4.4d). Re-landscaping of the area around the Market Cross would be a substantial benefit – wider pavements and a higher kerb with cast iron bollards would substantially protect the building and improve the setting (4). Developing a landscaping project here would probably be the best value project to protect the Market Cross fabric (1).
